FACILITY COMPLIANCE INSPECTION REPORT

Division of Waste Management Solid Waste Section

Date of Site Inspection: August 14, 2014

Waste Industries LLC - Stone Park Court Transfer Facility
 148 Stone Park Court
 Durham, NC 27703

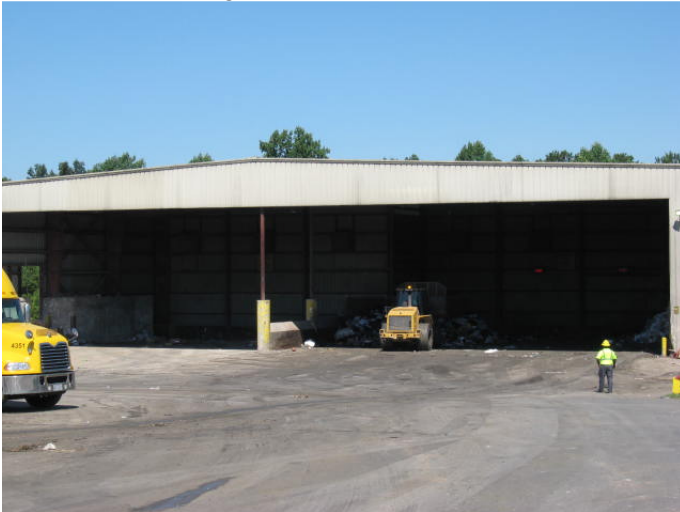
Transfer station (right: MSW and left: C&D)

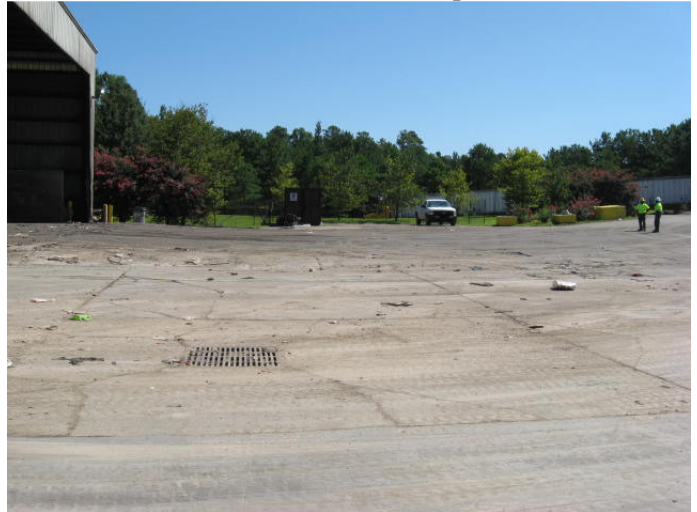
25. The transfer station appeared to be in good repair. Mr. Davidson stated that cracks in the concrete drive leading to the C&D tipping floor are scheduled to be repaired.

Cracked concrete scheduled to be repaired

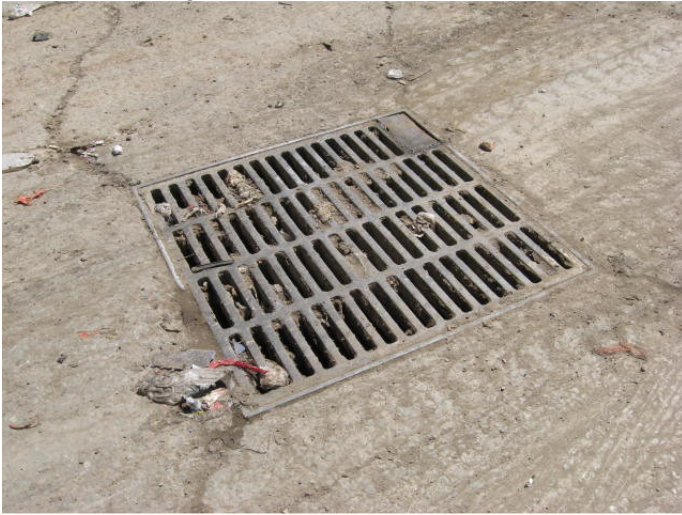
MSW leachate grate to be cleaned

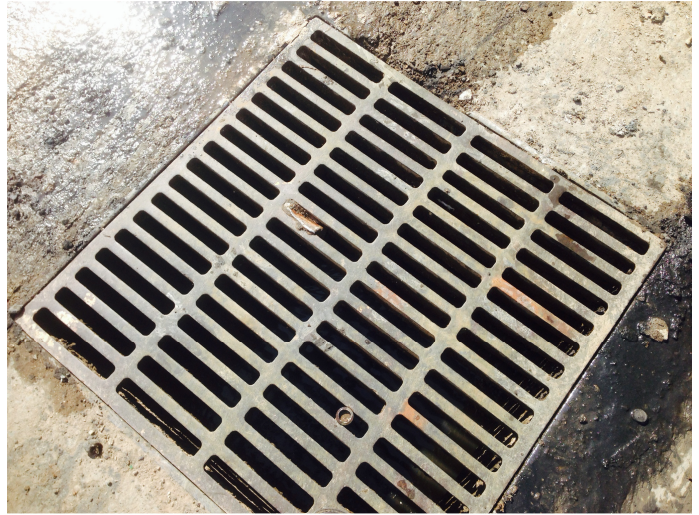
Cleaned MSW leachate grate (facility picture)

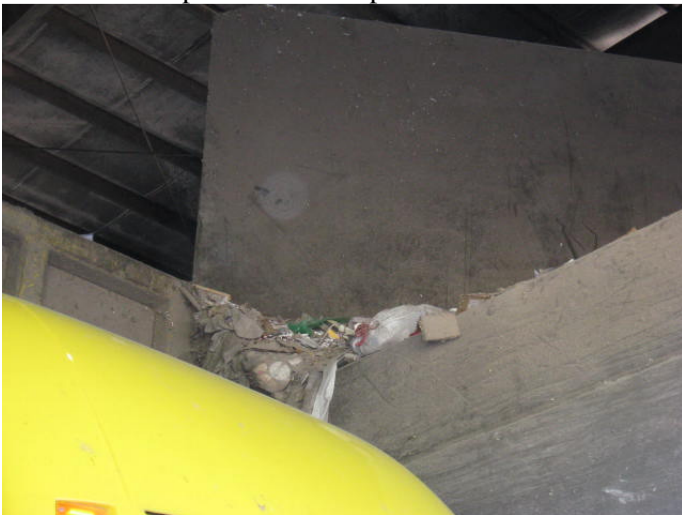
31. Solid waste was observed behind the push-wall (atop a ledge) leading into the MSW load-out bay. Mr. Davidson had the material removed and submitted a digital picture to SWS on 08/15/14.

Solid waste atop/behind MSW push-wall

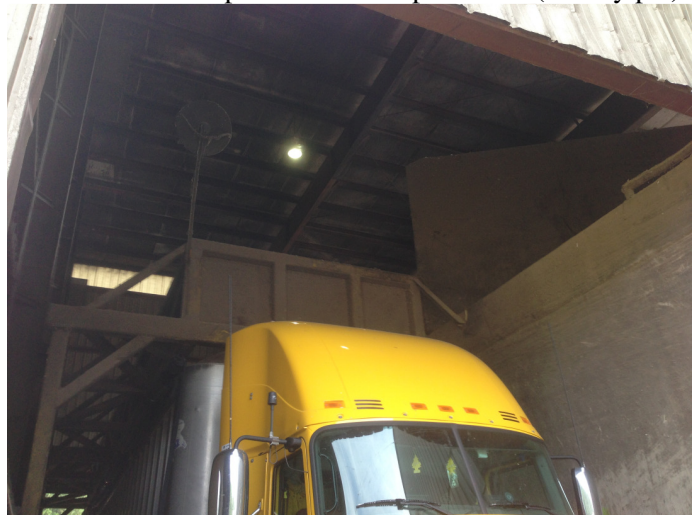
Cleaned area atop/behind MSW push-wall (facility pic)

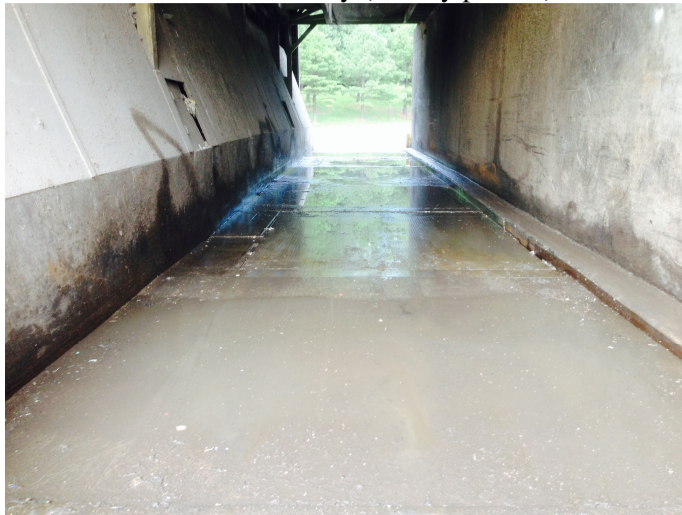
Cleaned MSW load-out bay (facility picture)

32. The leachate drain along the floor of the MSW load-out bay was not observed. Mr. Davidson had the load-out bay floor cleaned and submitted digital pictures to SWS on 08/15/14.

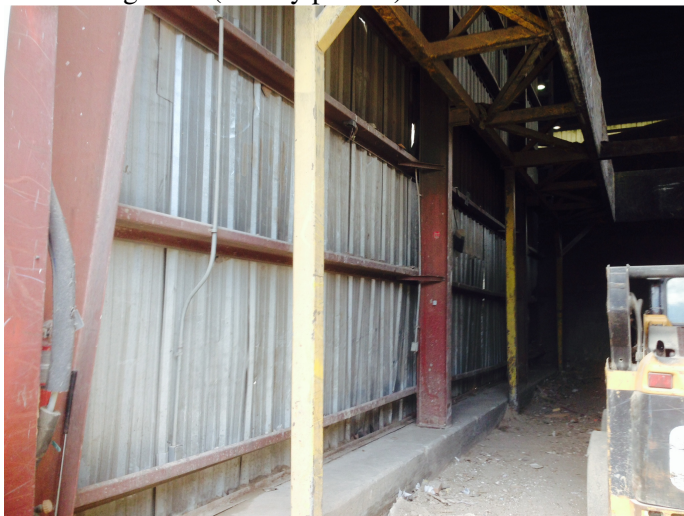
C&D load-out bay – solid waste removed from atop structural girders (facility picture)

26. Solid waste was observed atop structural girders in the C&D load-out bay. Mr. Davidson had the material removed and submitted a digital picture to SWS on 08/15/14.

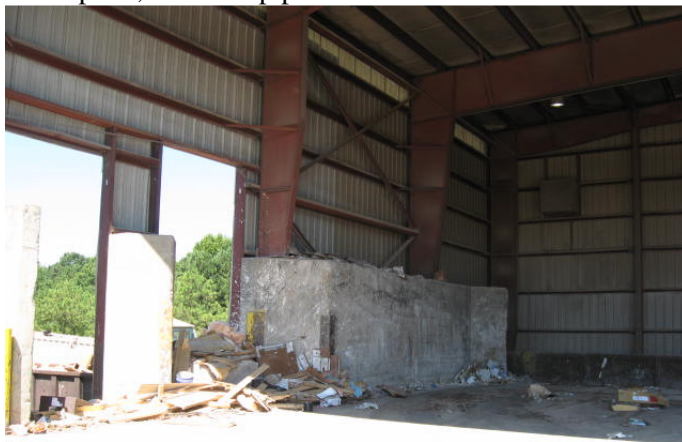
C&D tipping floor – reclaimed wood to be placed in dumpster, wood atop push-wall to be removed

28. Ensure C&D that accumulates atop the push-wall is removed daily.
29. The C&D load-out bay leachate grates were observed.
30. Ensure MSW fines that accumulate atop the concrete pad leading to the tipping floor are removed/area cleaned daily.
